# STRUCTURAL BUILDING ASSESSMENT

1800 Garnet Street  
Lynchburg, Virginia

**DECEMBER 17, 2021**

DAA Project Number: 2109460

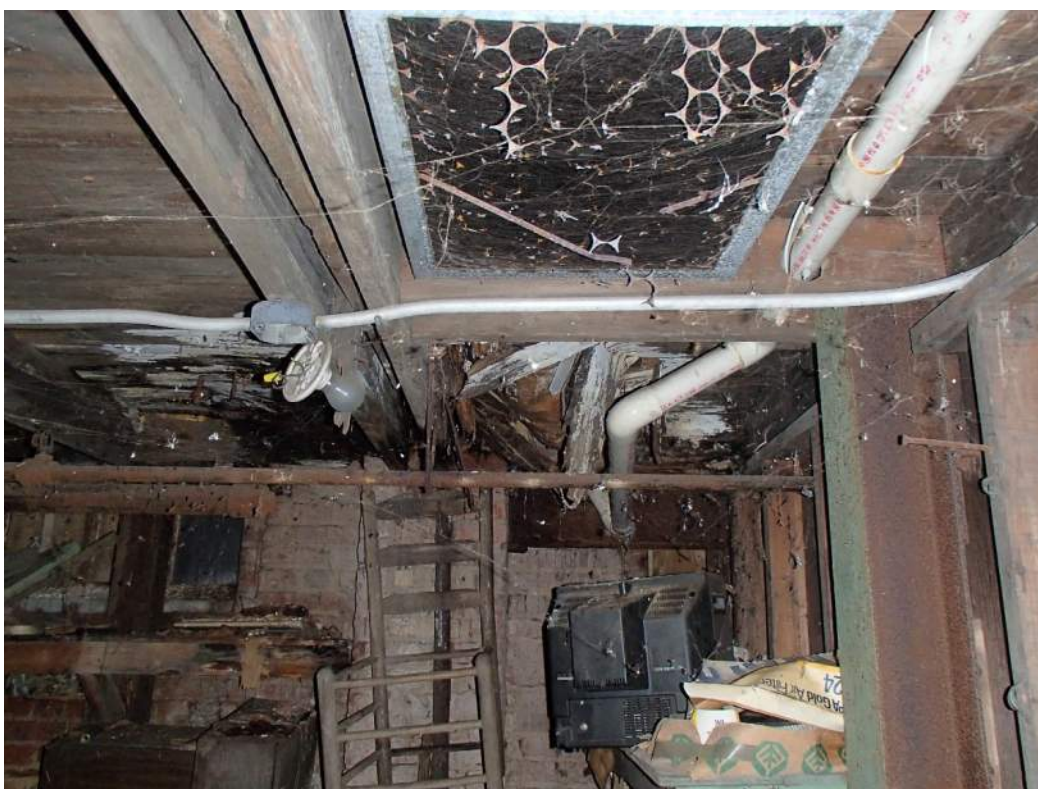
*Figure 2 - Water Damaged Wood Framing*

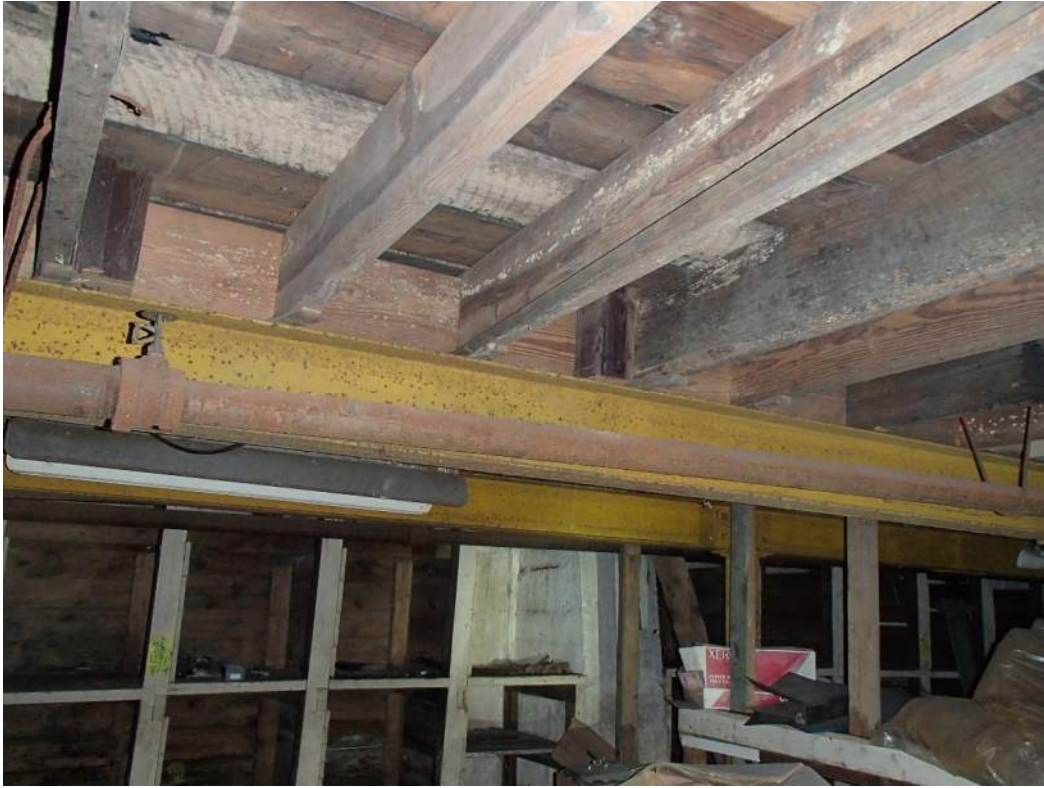
*Figure 3 - Typical Wood Framing*

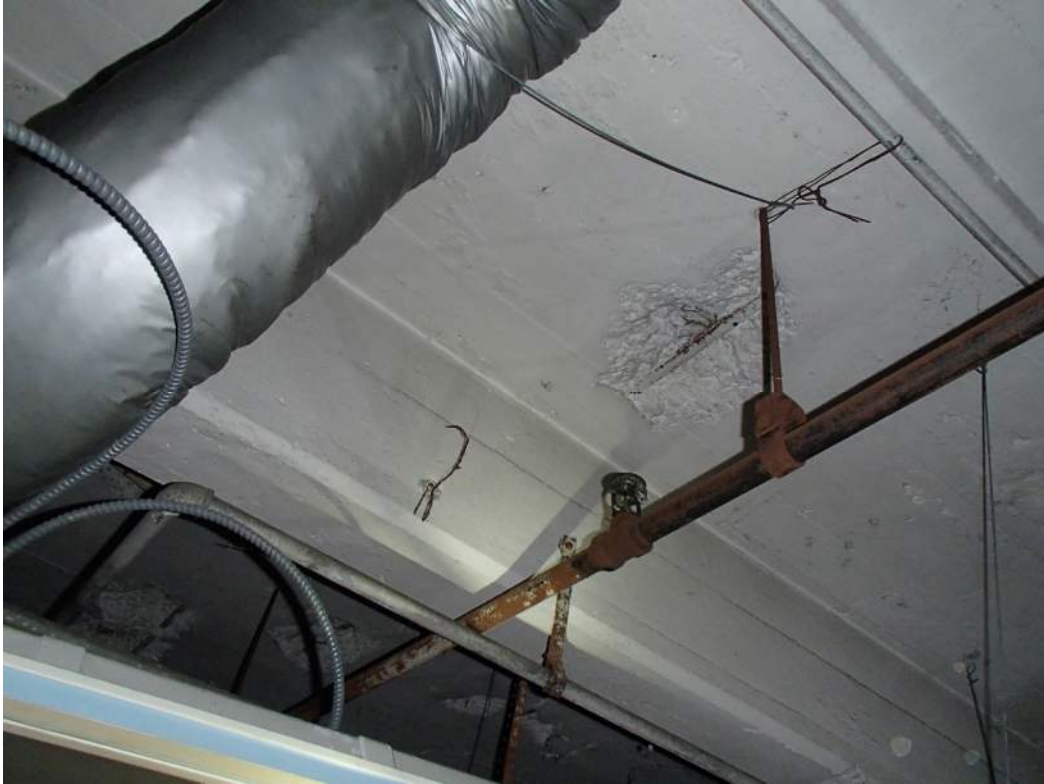
*Figure 4 - Typical Exposed Reinforcing Underside Level 2*

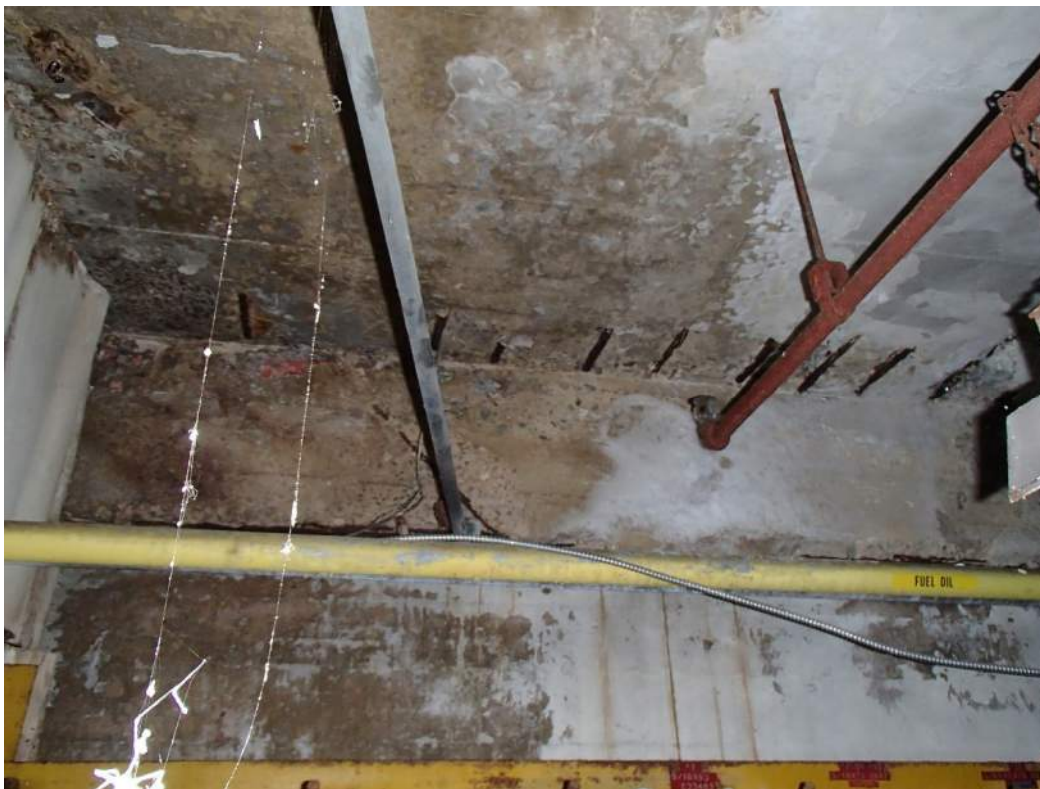
*Figure 5 - Exposed Reinforcing Underside Level 2*

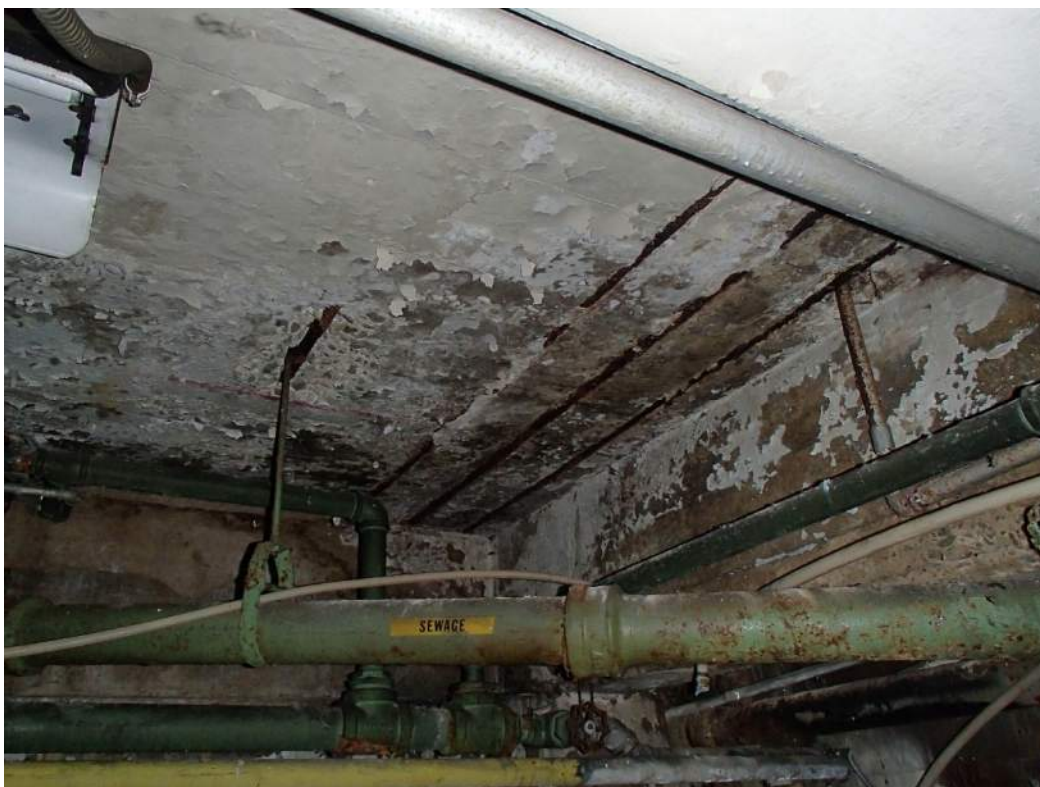
*Figure 6 - Corrosion Reinforcing Underside Level 2*

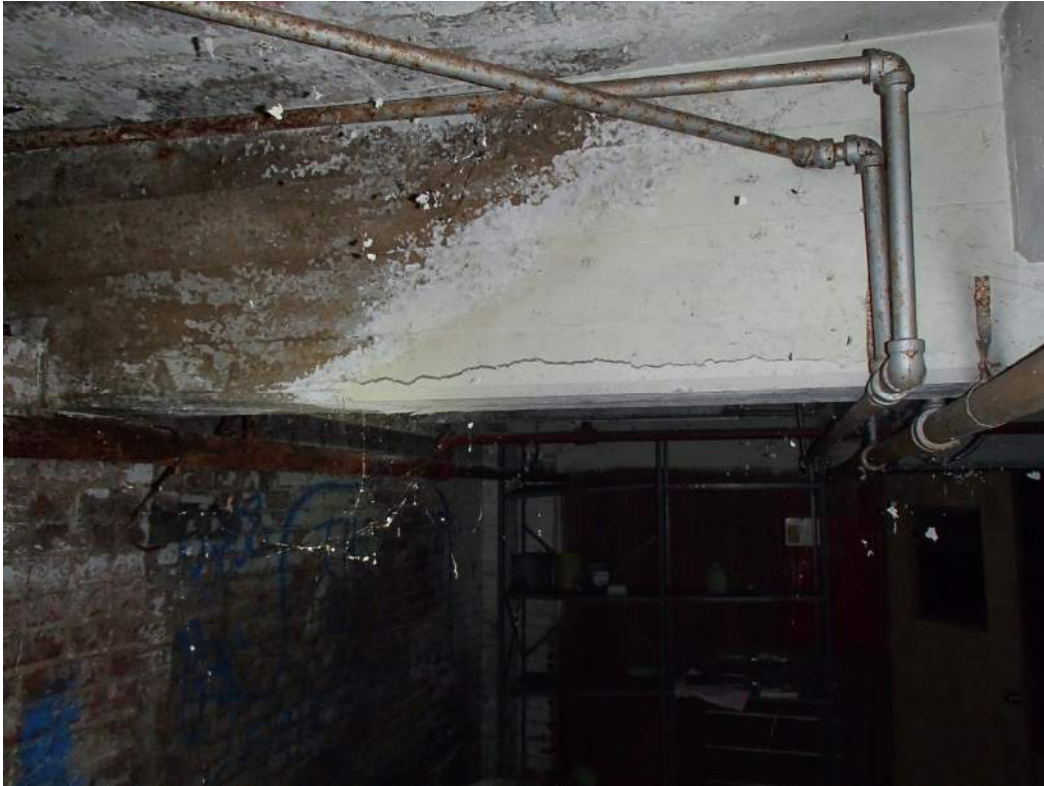
*Figure 7 - Cracking Framing Underside Level 2 - Likely Due to Reinforcing Corrosion*

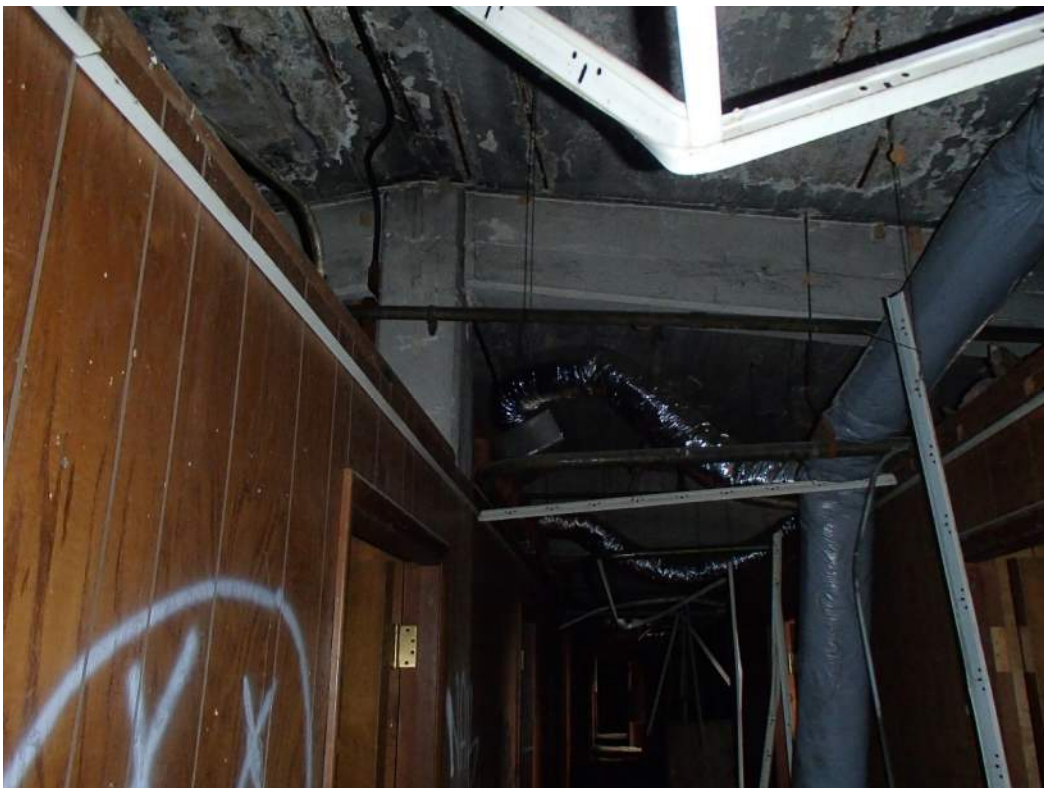
The underside of the concrete roof structure did have several areas of moisture damage and exposed reinforcing. The roofing material has failed and long-term exposure of the concrete slab to water has resulted in some penetration of the roof slab by water. This has resulted in what appears to be minor corrosion of the reinforcing in areas. Section loss of the reinforcing appears to be limited but the required cleaning and removal of unsound concrete to allow repairs will be required to confirm this observation. Access to the main roof was obtained through the penthouse located in the center of the structure. The concrete roof of this structure has issues similar to the main roof, but the roof is sloped, and water damage is less than observed in the primary structure due to water not ponding on the roof slab in this area.

*Figure 10 - Exposed Reinforcing Roof Level*

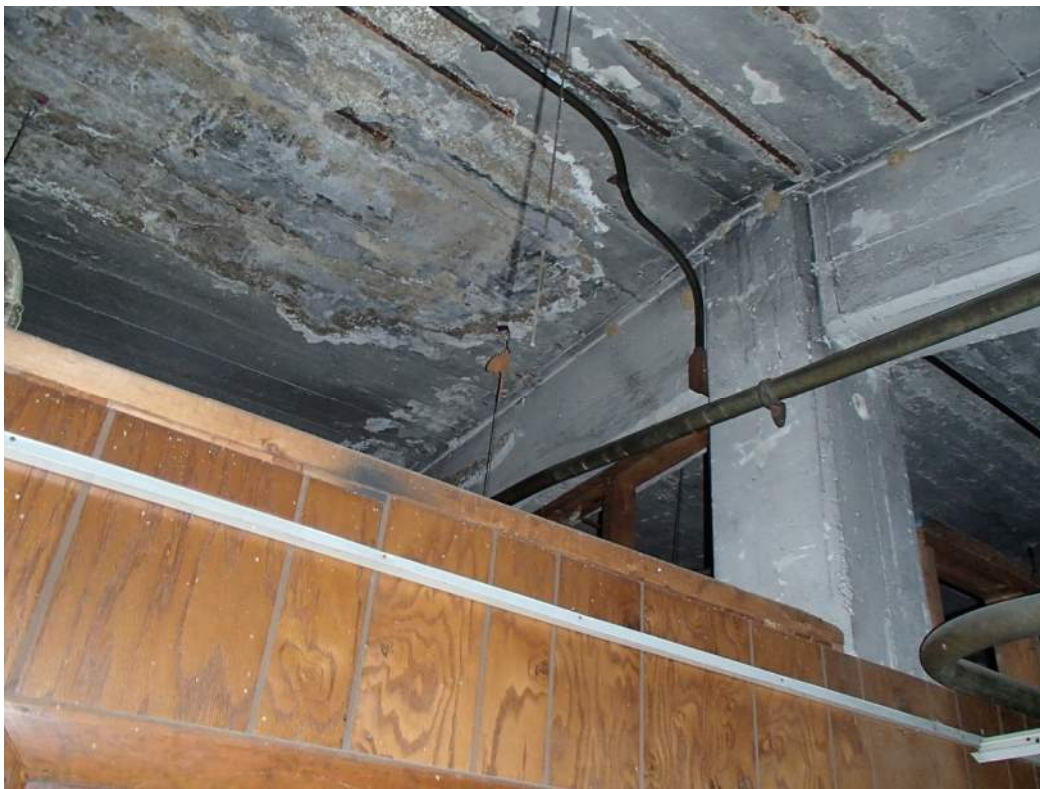
*Figure 11 - Visible Corrosion Underside Roof Level*

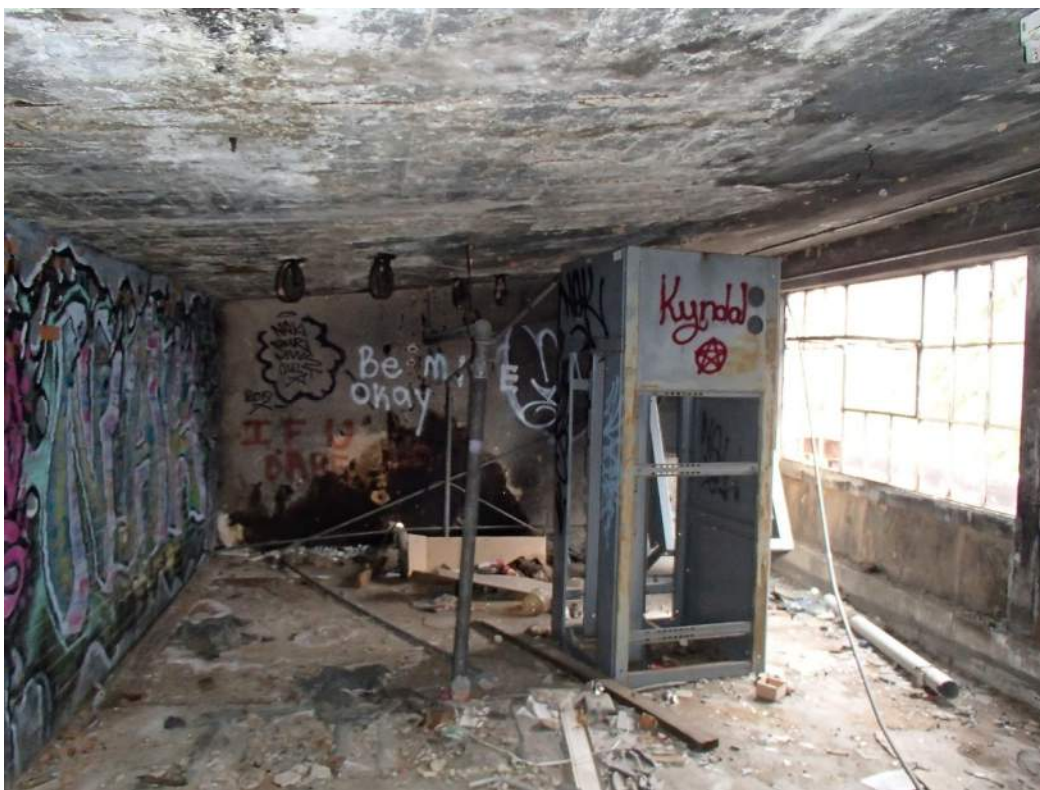
*Figure 12 - Underside Penthouse Roof*

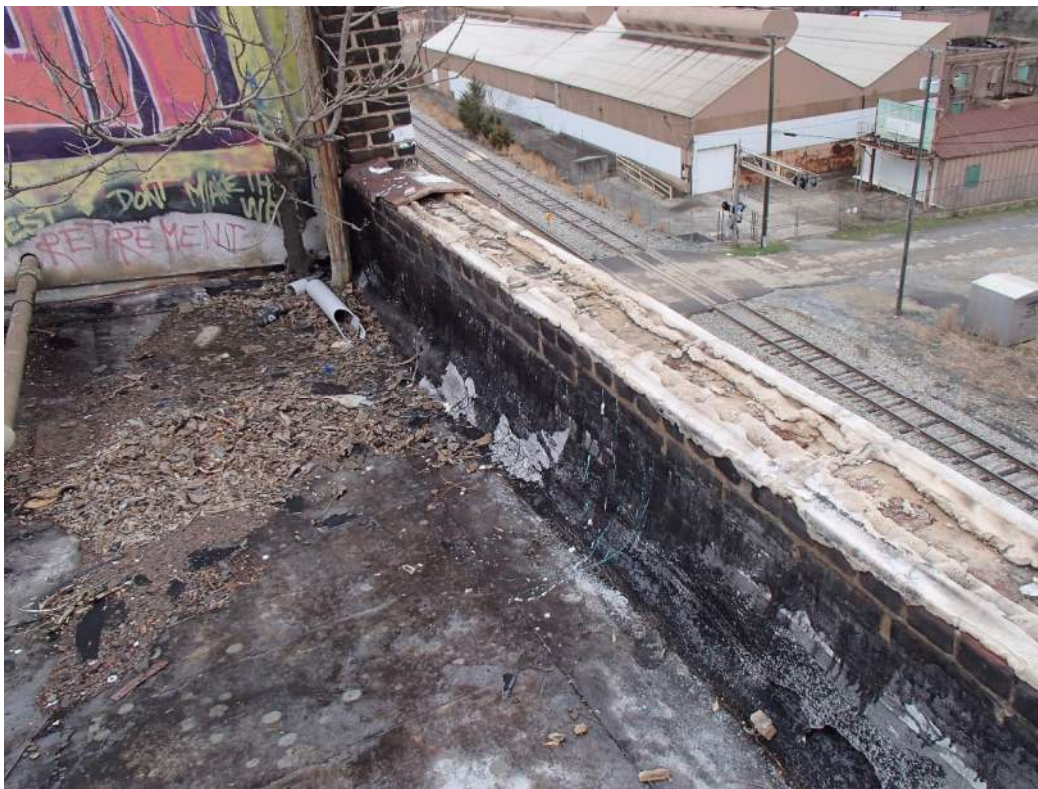
The roofing has failed and much of the perimeter the flashing between the roof and walls has failed also. Debris on the roof has clogged most of the roof drainage and this results in water ponding on the roof in areas. The brick masonry walls extend past the edge of the roof surface and originally had a cast tile coping. The coping served to seal and protect the brick masonry from water along the top and prevent moisture intrusion into the wall system. A significant portion of the tile coping has been damaged or removed. Several loose tiles were observed, and the missing tiles were not present on the roof surface. The failed roofing, flashing and damaged coping are allowing moisture intrusion into the building and are the primary cause of damage to the structure.

*Figure 13 - Damaged Coping, Flashing and Roof*

To extend the useful life of the structure the building must be protected from the effects of weather. The roof and exterior envelope need to be repaired to prevent moisture intrusion into the building space and structural elements. Drainage from the roof should be collected and directed away from the building at the ground level. The top of the parapet walls should be repaired to prevent water intrusion into the brick masonry walls.

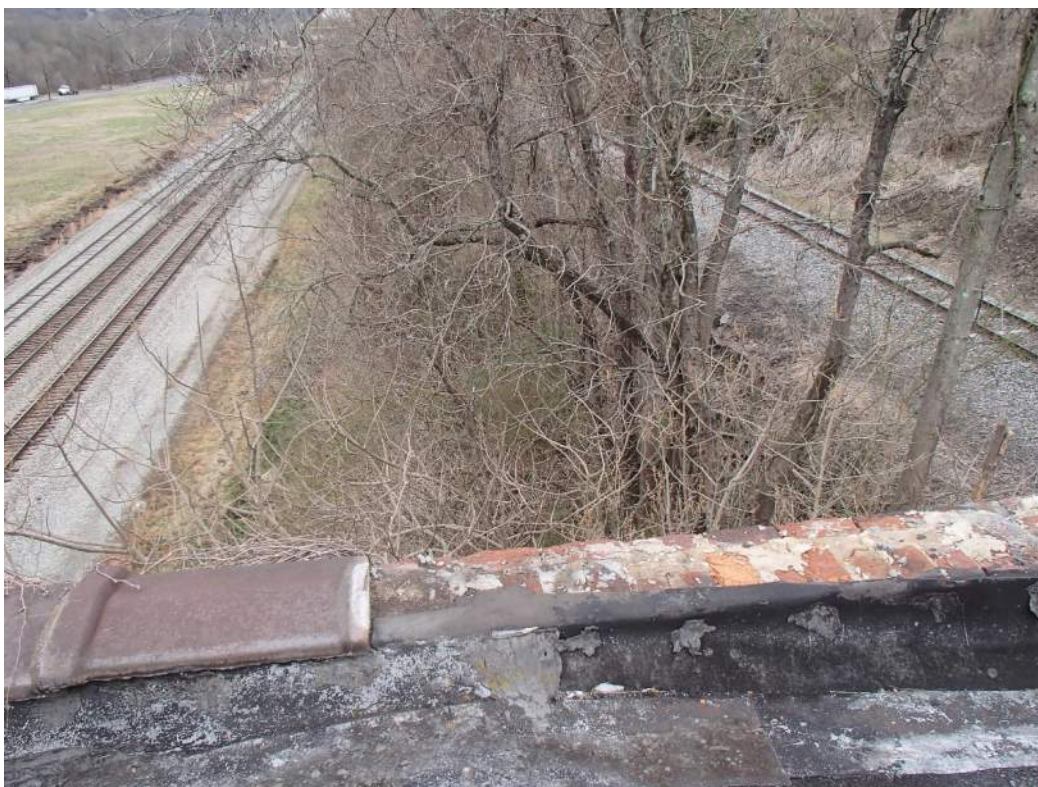
*Figure 14 - Damaged Coping and Flashing*

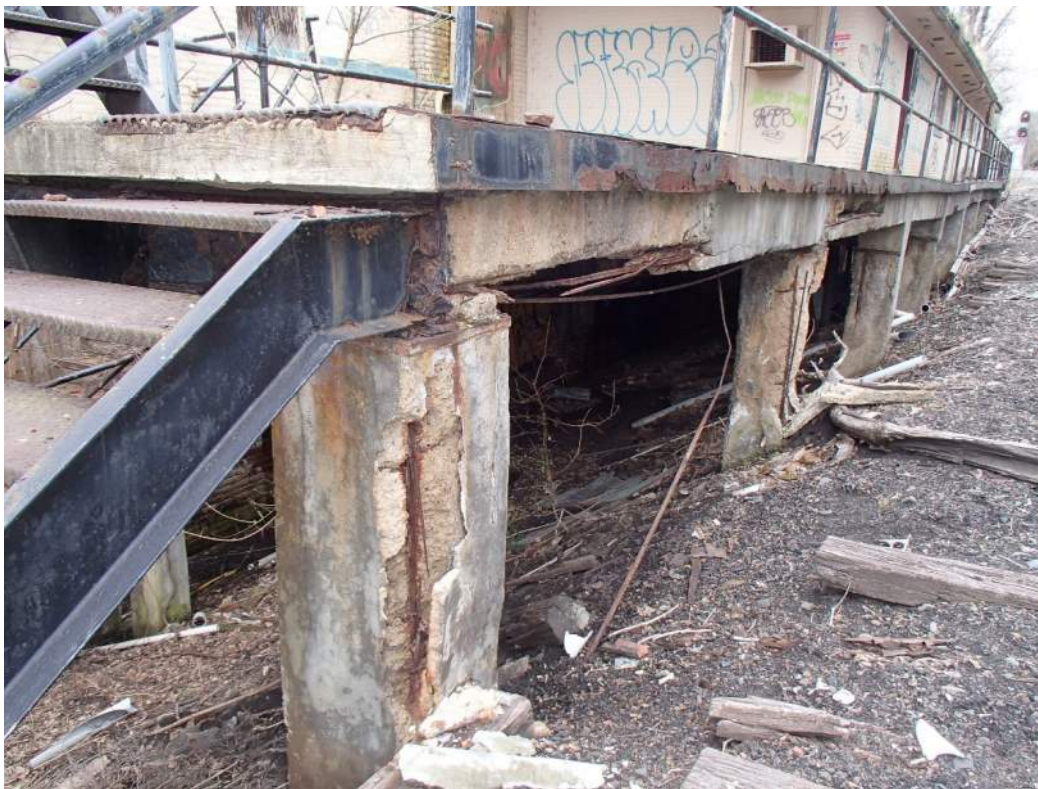
*Figure 15 - Rear Platform*

The severely damaged platform at the rear of the building should be demolished and removed. It can not be economically repaired. Beyond this platform on the east end of the building are several small steel frames which should also be removed. These appear to have been some type of equipment or associated item supports.

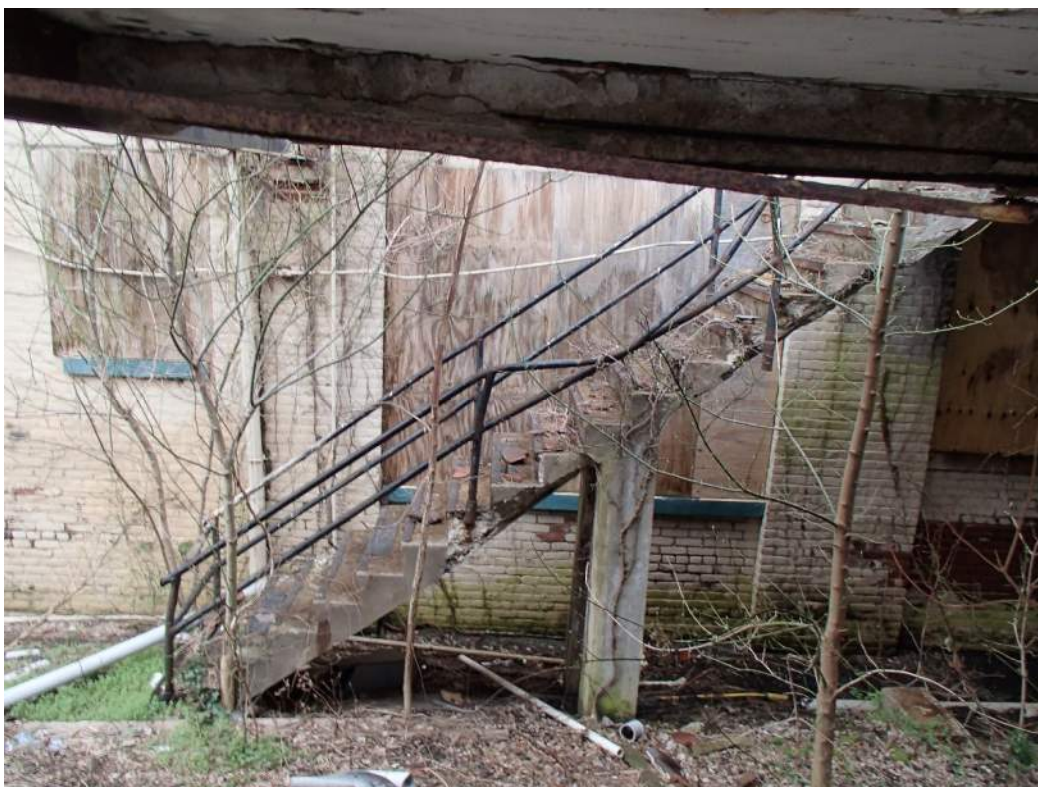
*Figure 16 - Platform Stairs*

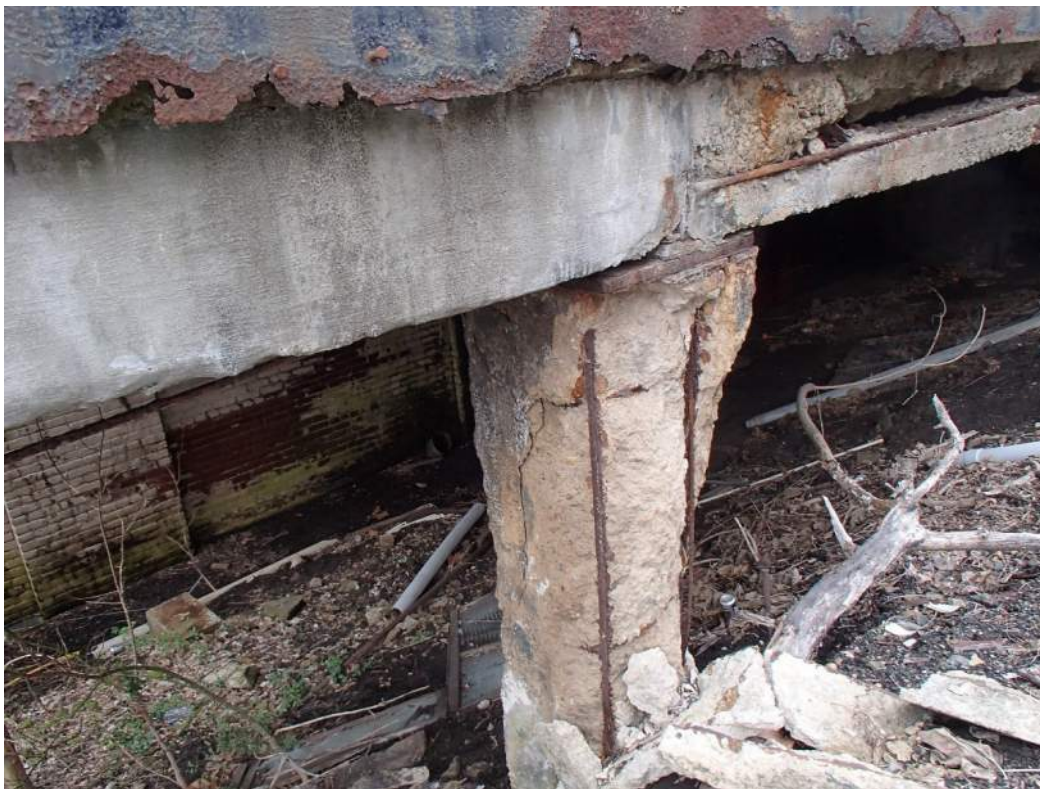
*Figure 17 - Damaged Platform Support Pier*

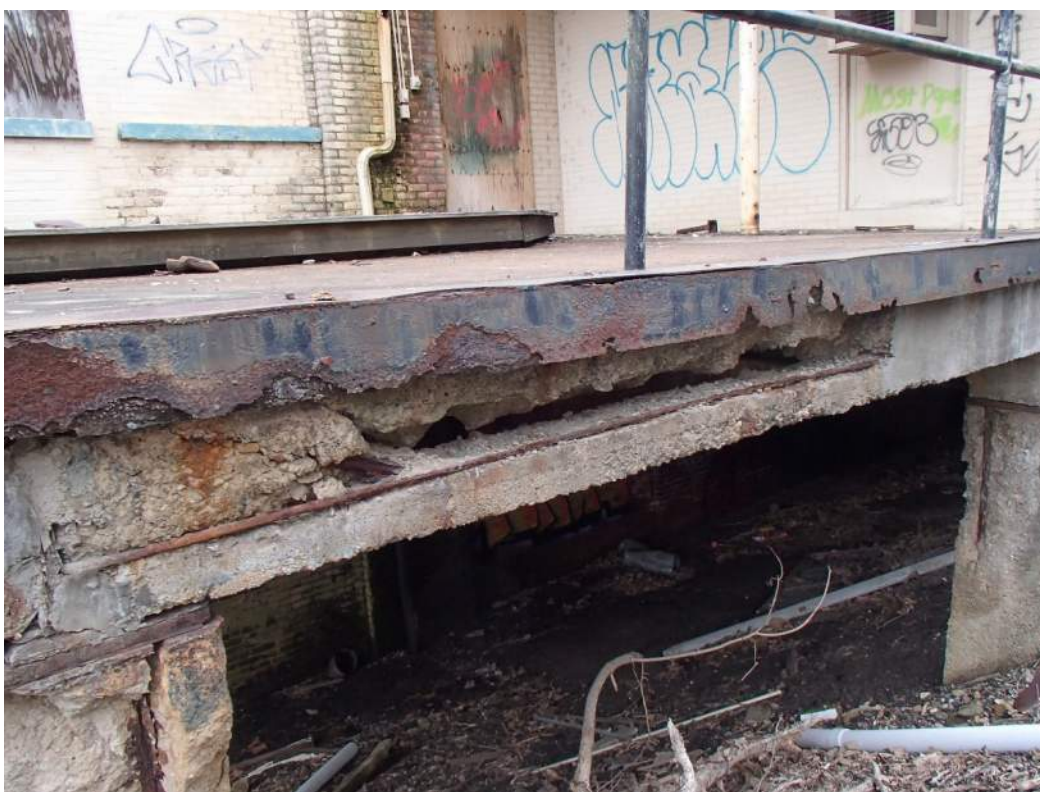
*Figure 18 - Platform Edge Beam - Total Loss of Section*

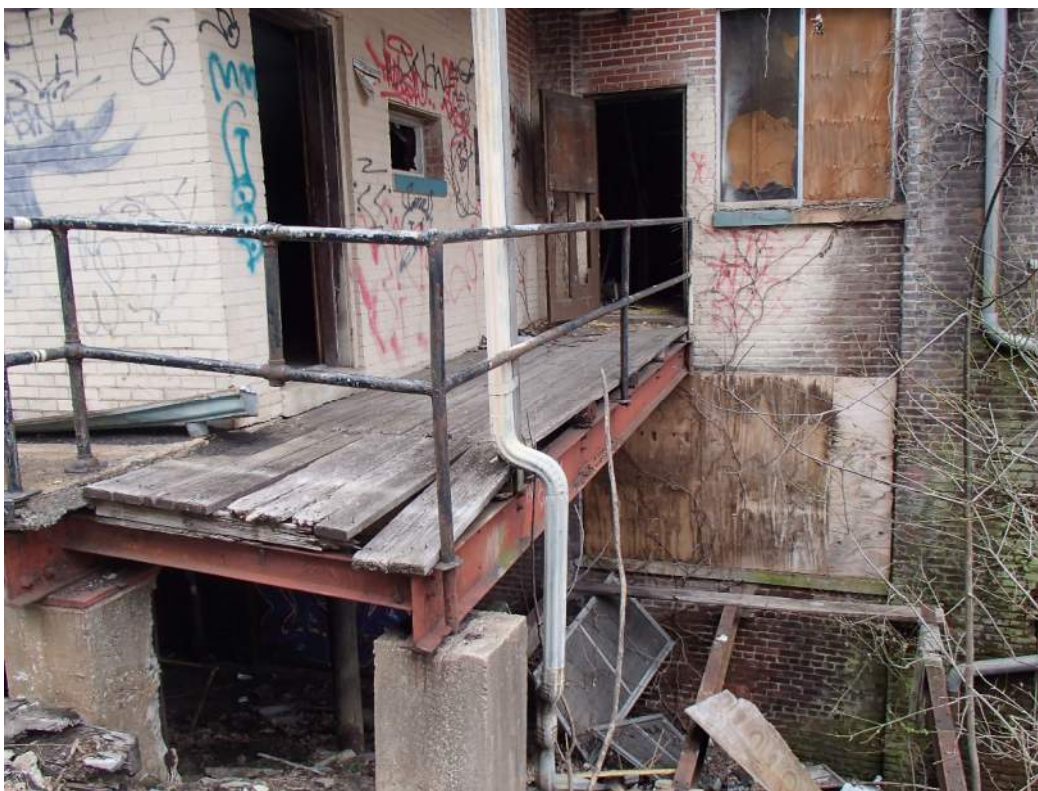
*Figure 19 - South Side Structure Off Platform*

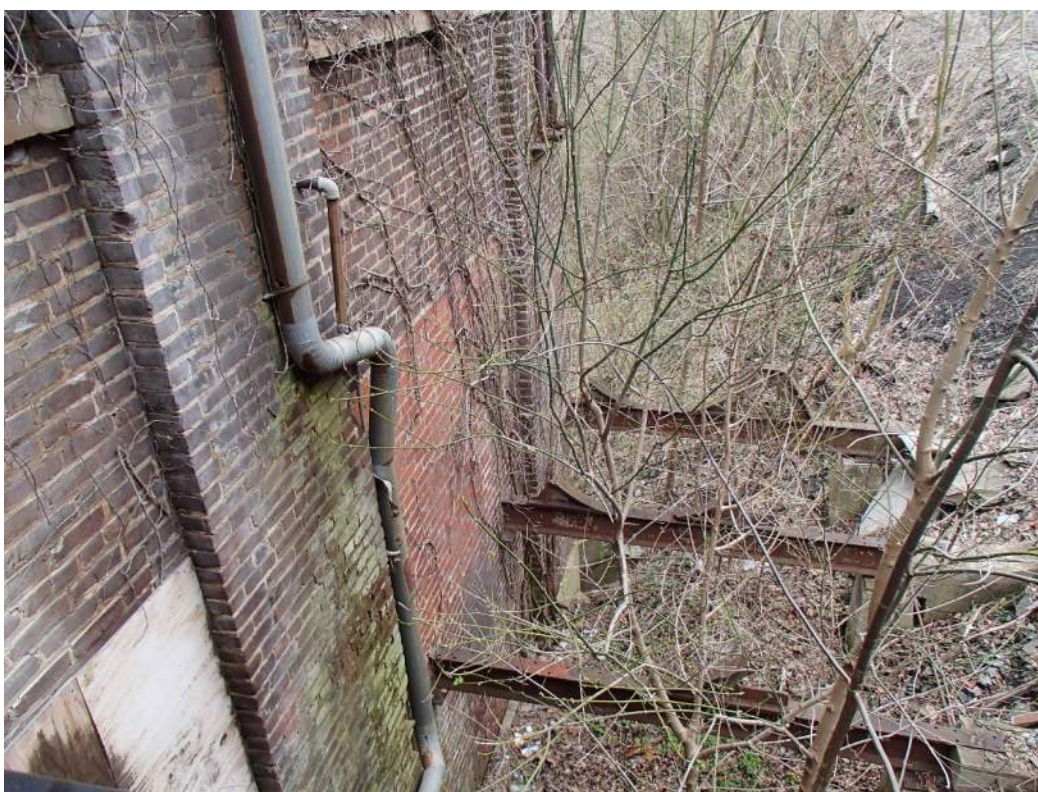
*Figure 20 - Steel Support Structure East End of Building*

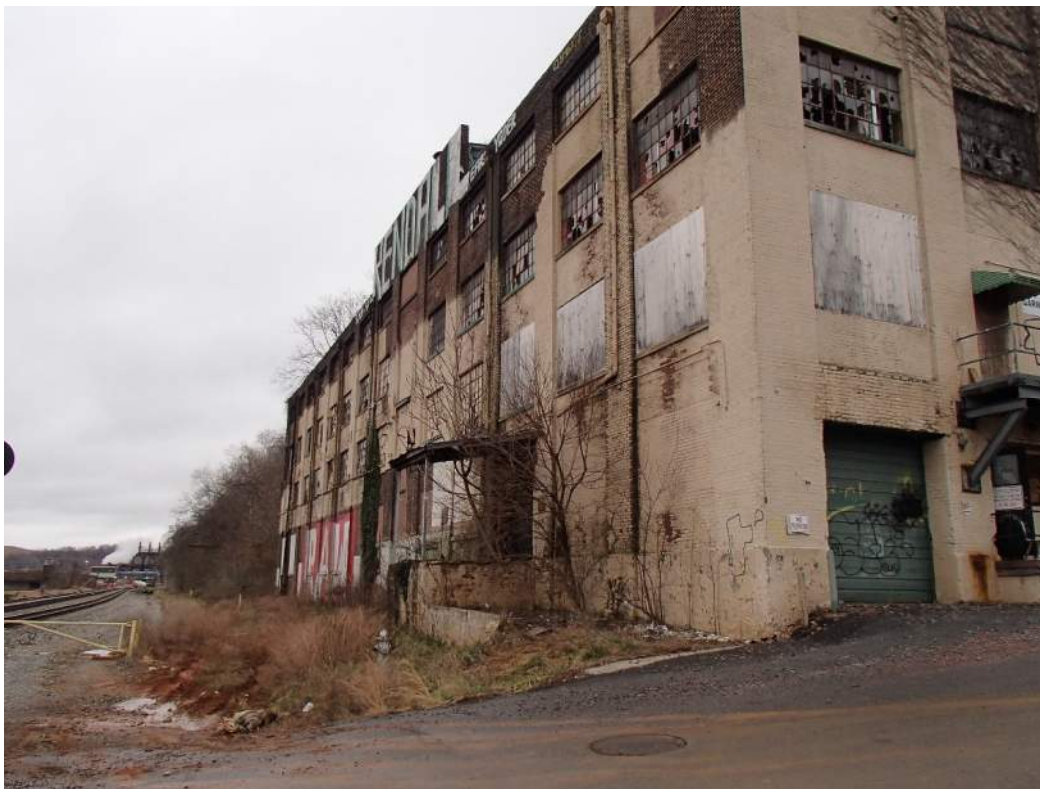
Figure 21 - Front Exterior of Building

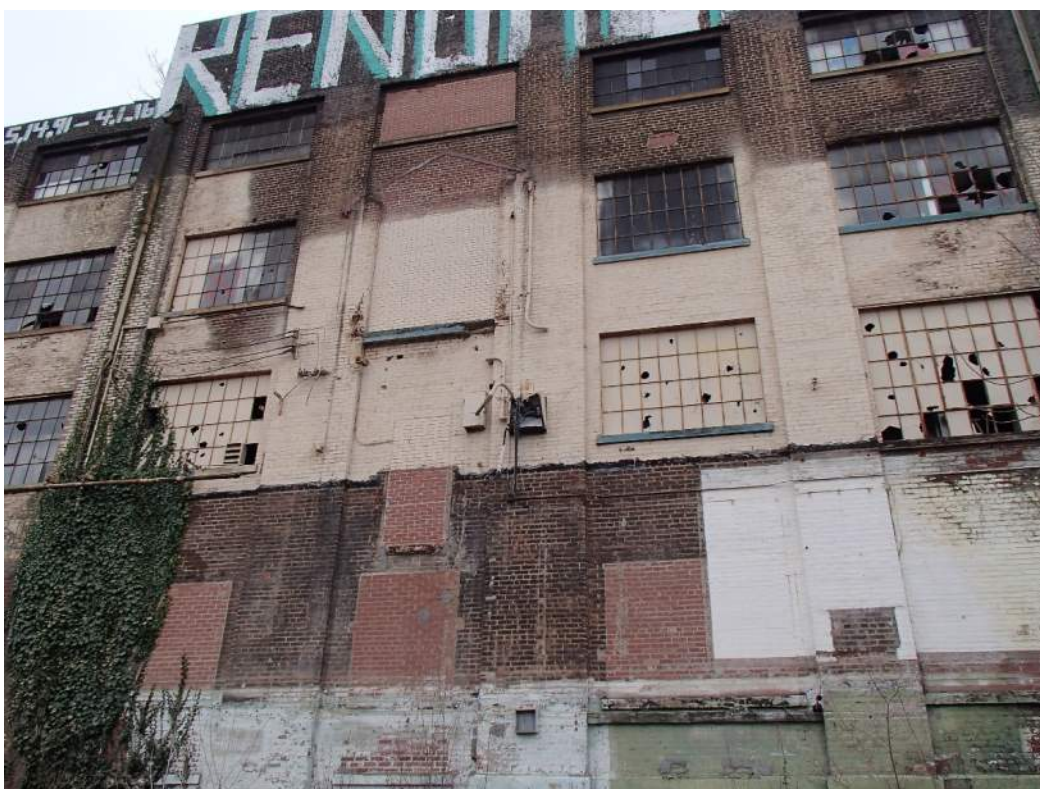
Figure 22 - Infilled Areas of North Side

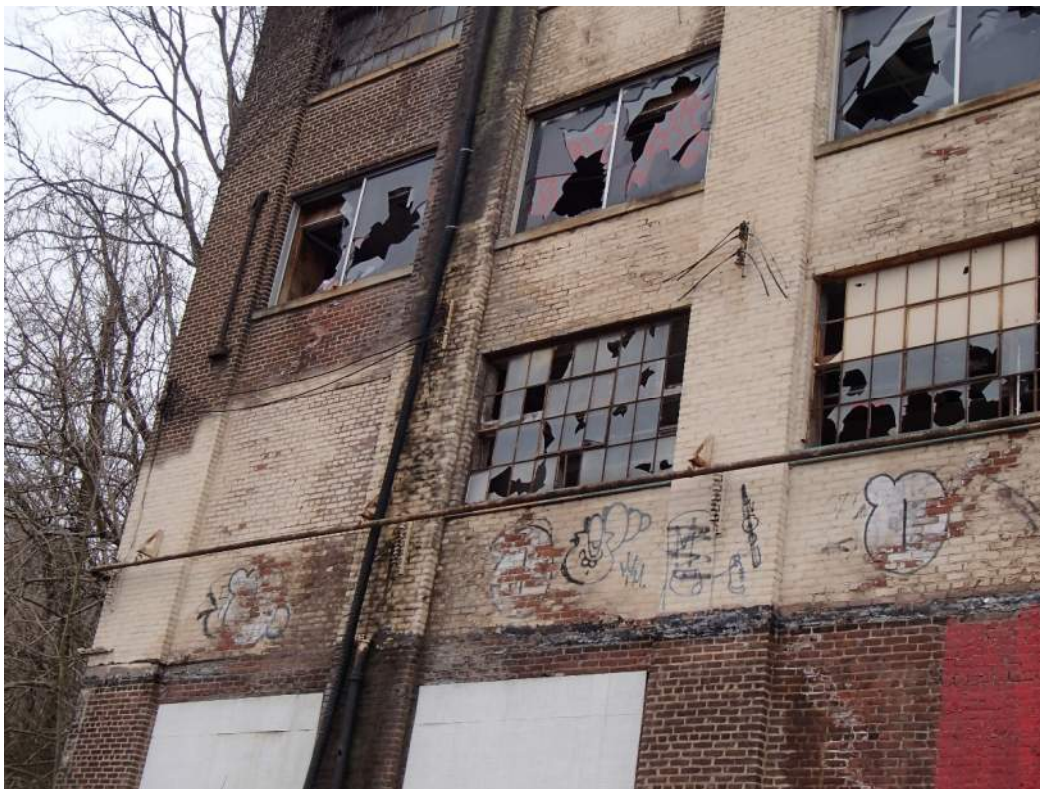
The exterior of the building appears to be in fair condition with the exception of the rear concrete and steel platform and ancillary structures. The exterior consists of brick masonry walls which are infilled between the concrete framed structure. There are localized areas of damage to the brick with the most noticeable areas being located on the front north side of the building where attached structures appear to have been removed in the past. Openings at the second and third levels have been blocked in and it appears some coverings of these opening has been removed. Moisture damage to the brick has resulted in damage to the brick in some areas where the bricks have absorbed water and then suffered repeated freeze thaw damage. These areas appear to be limited and located primarily near roof drainage downspouts or other piping supported by the exterior walls. Almost every window of the structure has been damaged to some extent or is missing. The openings allow water and wildlife into the building and are contributing factor to water damage of the structure.

*Figure 23 - Typical Damaged Brick Masonry & Windows*

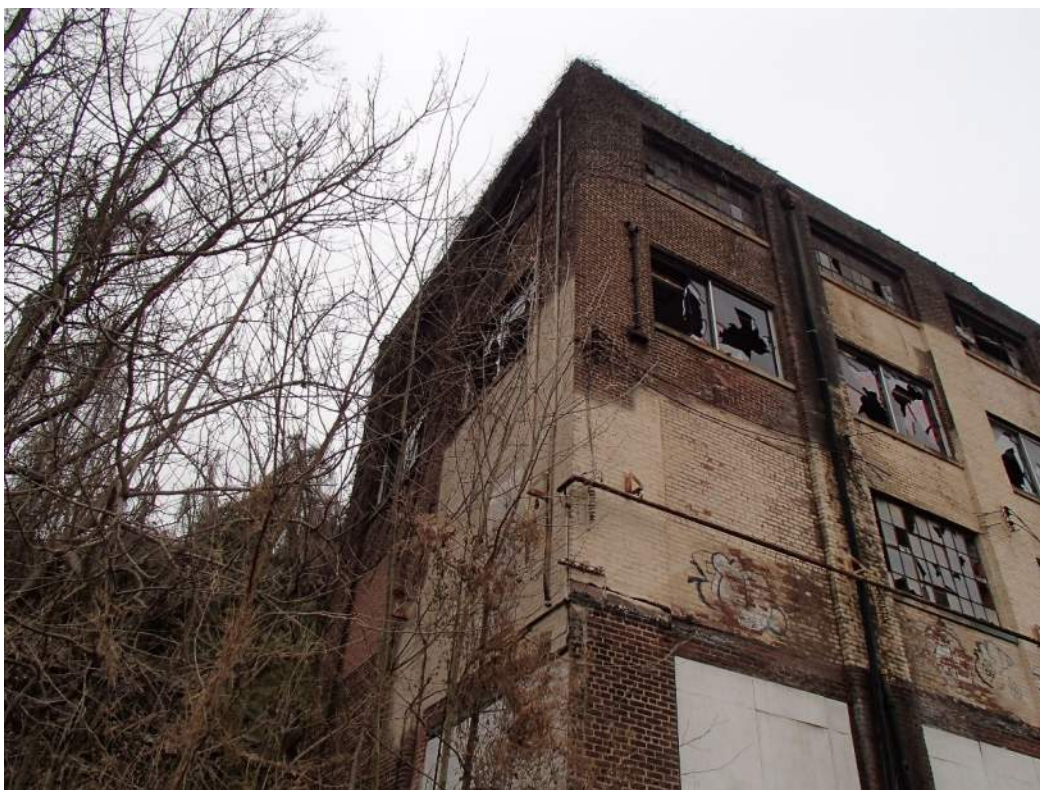
*Figure 24 - East End of Building*

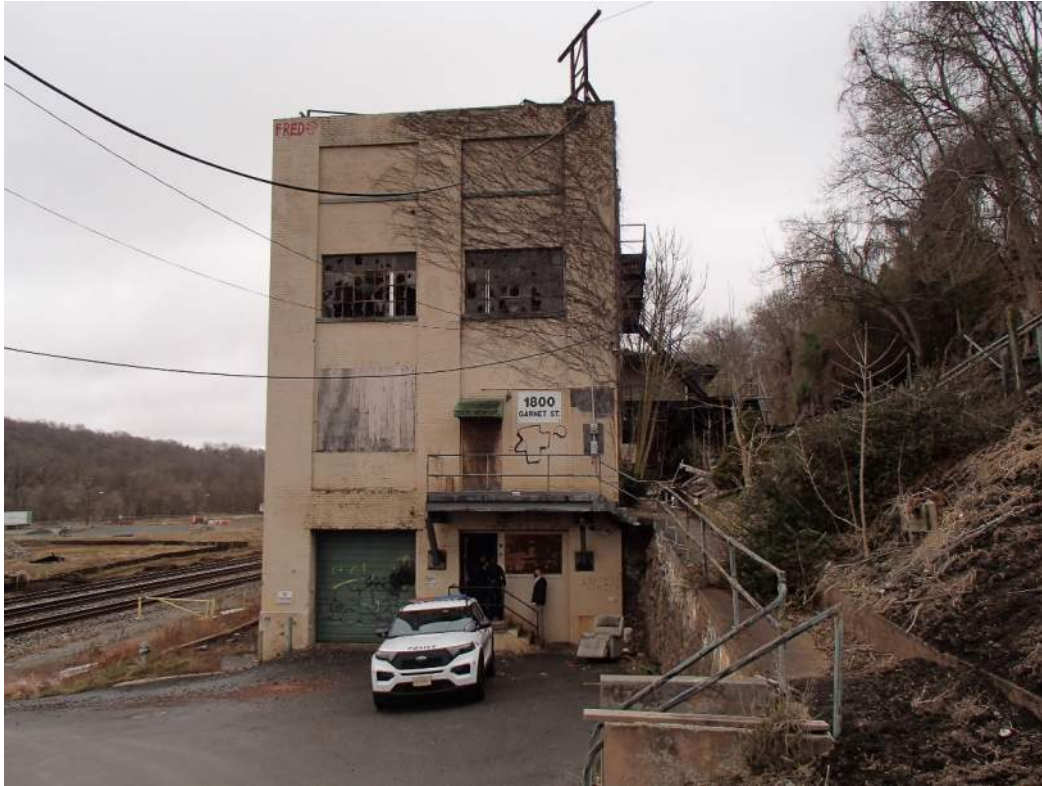
*Figure 25 - West End of Building*
